Cos Phi expertise helps grain elevator improve electrical systems efficiency and achieve utility savings to pay for it.

Segment:
Grain Elevator

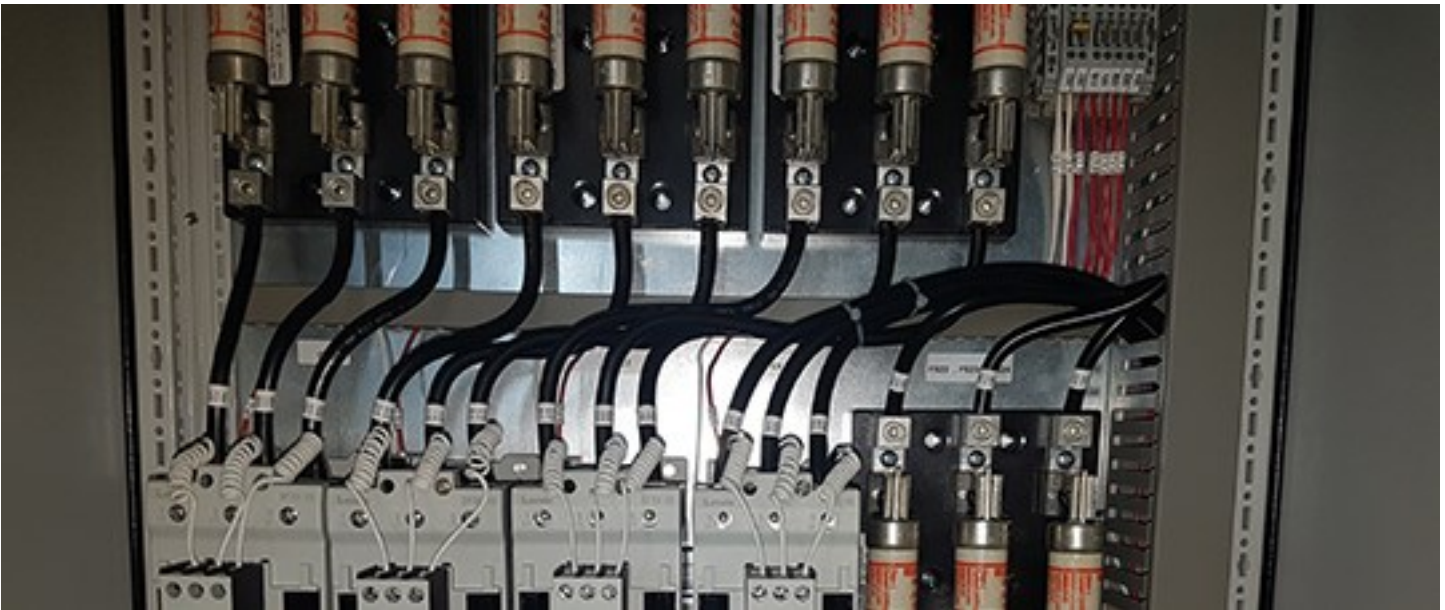
This led to Cos Phi recommending a custom de-tuned (harmonically filtered), automatically switched, low voltage power factor correction bank. The capacitor bank was installed at the main electrical panel.

The automatic PFC capacitor bank system was designed so that it will automatically switch capacitors in and out of the electrical system in order to maintain a pre-determined level of power factor correction. Additionally this PFC bank has an intelligent controller which monitors system kVAR, Voltage, Amps and harmonics.
